ERDC/GSL TR-17-13

Geotechnical Evaluation of the Brownsville Levee Cracking and Partial Slope Failure

June 2017

Final report

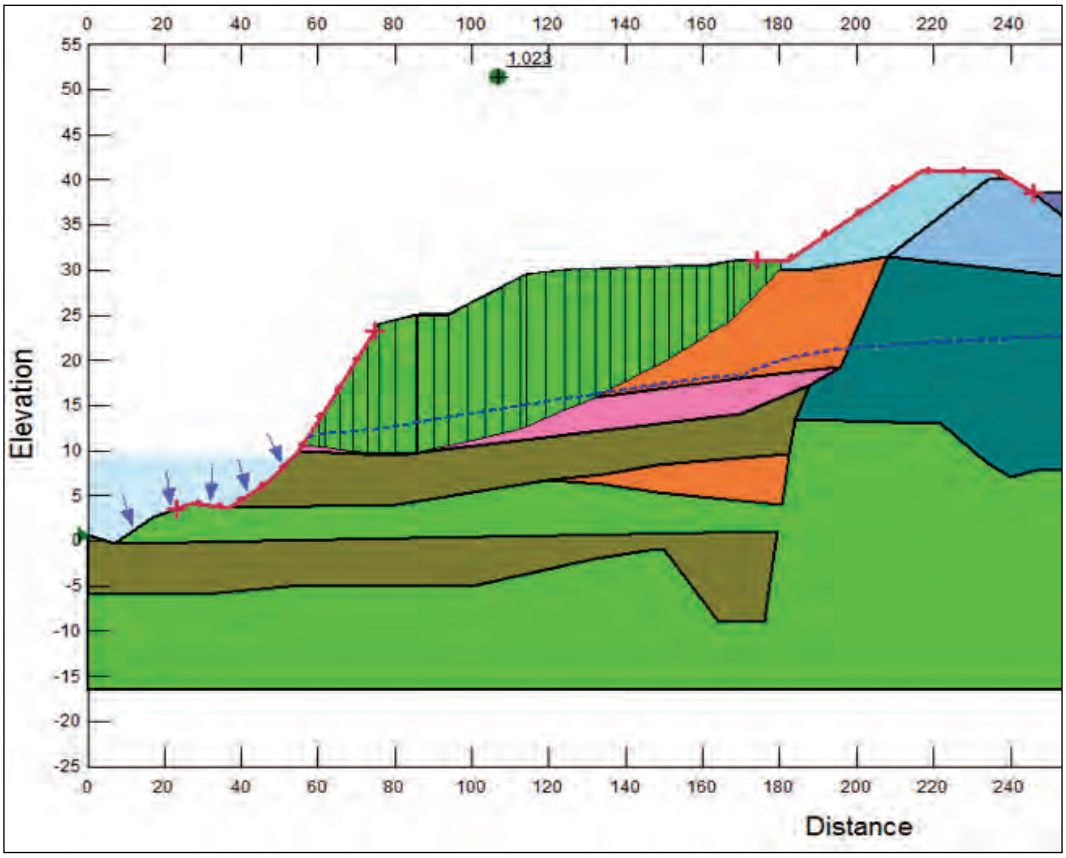
Figure 6.14. Results of stability analysis station 1900+13, hydrograph loading t = 1.64E7s.

Figure 6.14 shows the results of both the transient seepage and stability analyses conducted at station 1900+13. The factor of safety was calculated to be 1.02 and occurred at a time of 1.64e6 sec after the hydrograph peak. The undrained shear strength assigned to the weak zone was 150 psf. Figure 6.15 shows the river elevation on the left vertical axis plotted against time and the factor of safety calculated at discrete points (right vertical axis).

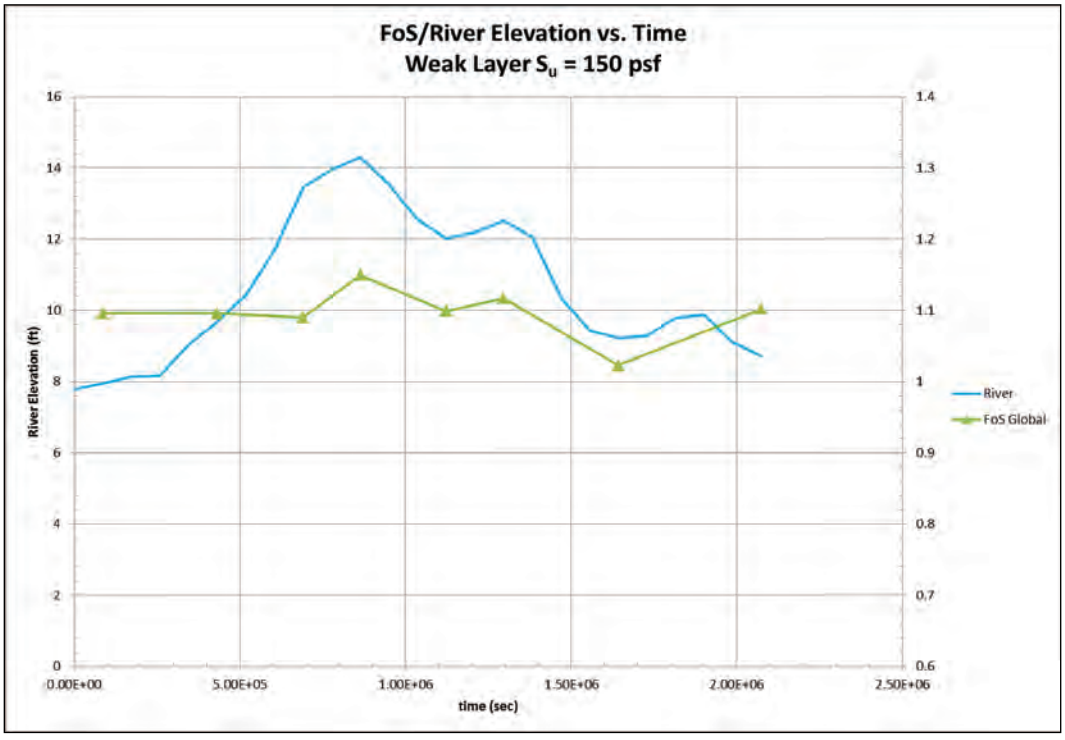
Figure 6.15. Results of transient seepage/stability analysis at station 1900+13; FoS = Factor of safety.

The factors of safety shown in Figure 6.15 were as expected. As the hydrograph peak was occurring, the highest factor of safety (1.15) was calculated (1.15) because of the stabilizing effect of the water weight against the riverbank. Once the river stage drops, the factor of safety decreases with a slight increase due to a second smaller increase in river elevation then the factor of safety decreases rapidly enough that the materials above and below the soft ML layer do not have time to dissipate the pore pressures generated during the flood loading. There is an increased weight associated with the excess pore fluid. The reason the factor of safety decreases, after the peak of the hydrograph has been reached, is due to the excess weight of the saturated materials with no reinforcing effect of the water.

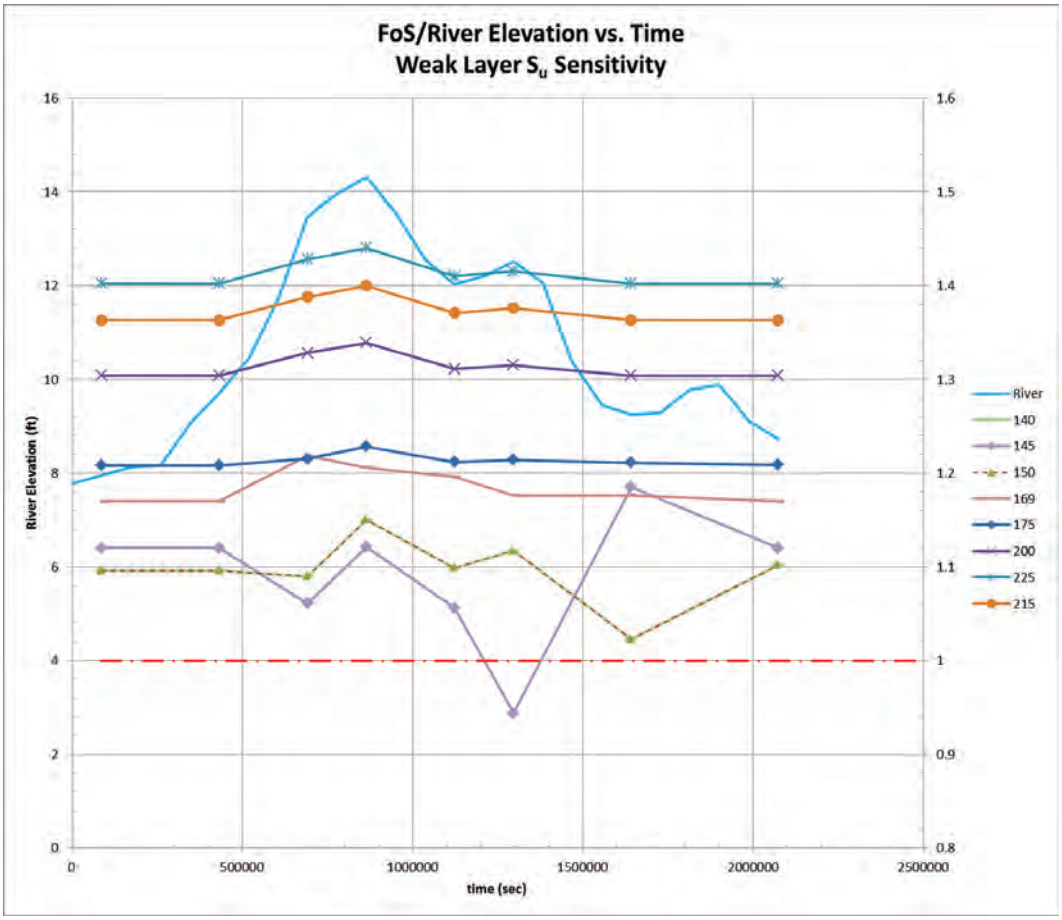
Figure 6.16. Results of sensitivity analysis on station 1900+13.

A sensitivity analysis of the undrained shear strengths in the soft ML material was conducted to better understand the response of the levee to the drawdown event that seemed to have triggered the levee cracking. Figure 6.16 shows the result of this sensitivity study. The undrained shear strength of the soft zone was varied from 140 to 225 psf. The same general trend of increasing factor of safety with increasing river stage until the peak of the hydrograph occurs is found for all the shear strength values used. The trend skews when a value of 169 psf or less is used. This is due to a change in failure surface geometry. Figure 6.17 shows the failure surface with the soft ML assigned a shear strength value of 215 psf. The same failure surface search limits are used for the rest of the sensitivity analysis. In this case, both the entry and exit limits of the search are defined as well as the minimum tangent for the circle. When the failure surface intercepts the end of the entry line (red line segment with crosses at the beginning and end), it means that the minimum surface may be located outside the bounds of the current search. In order to find the minimum, either another search method can be used or the entry line must be relocated. When another search method (block search method) was applied, it revealed that the minimum surface was located closer to the river.

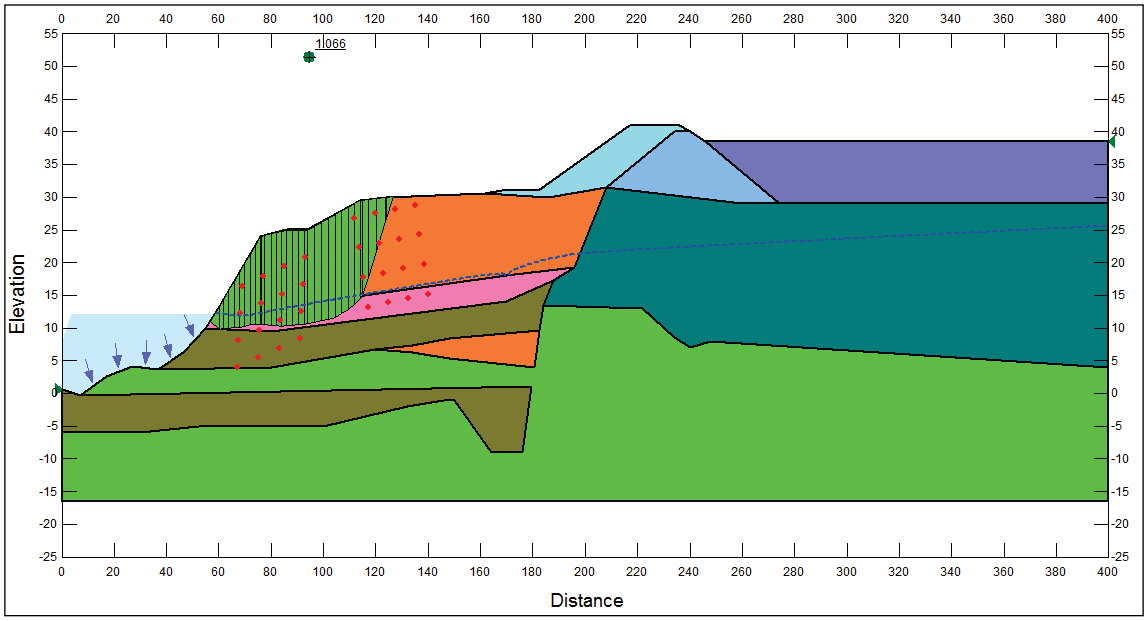
When the block search method was employed (Figure 6.18), a minimum failure surface that was close to riverbank and the minimum factor of safety was 1.07 in this case at t = 1.12e6 s. If the search was set closer to the bank of the river, an infinite failure mode was obtained. This is a product of the SM material not having a cohesion value and the steepness of the riverbank. Factors of safety for infinite slope analysis were less than 1.0 indicating that the bank should not be that steep and may be actively failing or that the friction angle for the SM material was set too low. Observations made during a December 2014 visit by ERDC indicate that the bank is sloughing due to its steepness and possible river undercutting (see Figure 6.19). The higher factor of safety was reported in Table 6.3 to provide continuity between search methods and failure modes.

Figure 6.18. Failure surface at station 1900+13, riverbank failure.

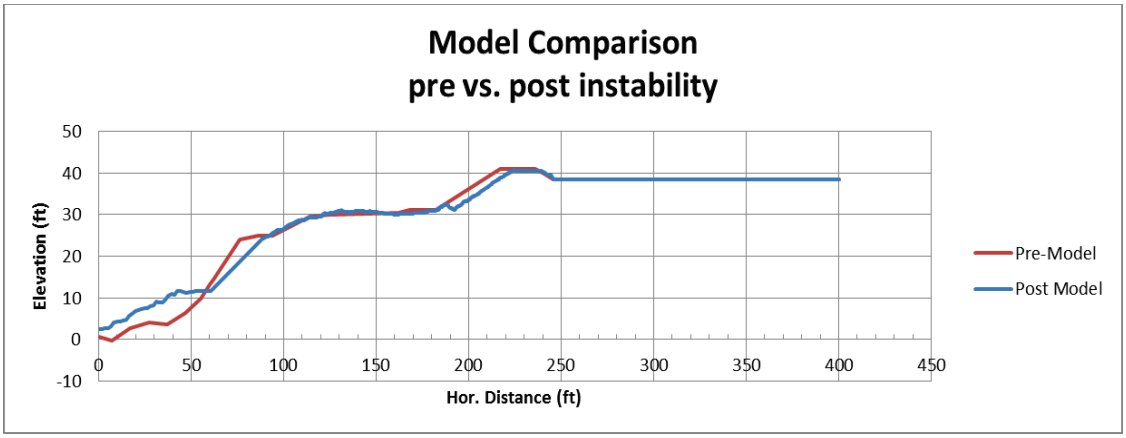
Figure 8.1. Model surface data comparison before and after levee instability.

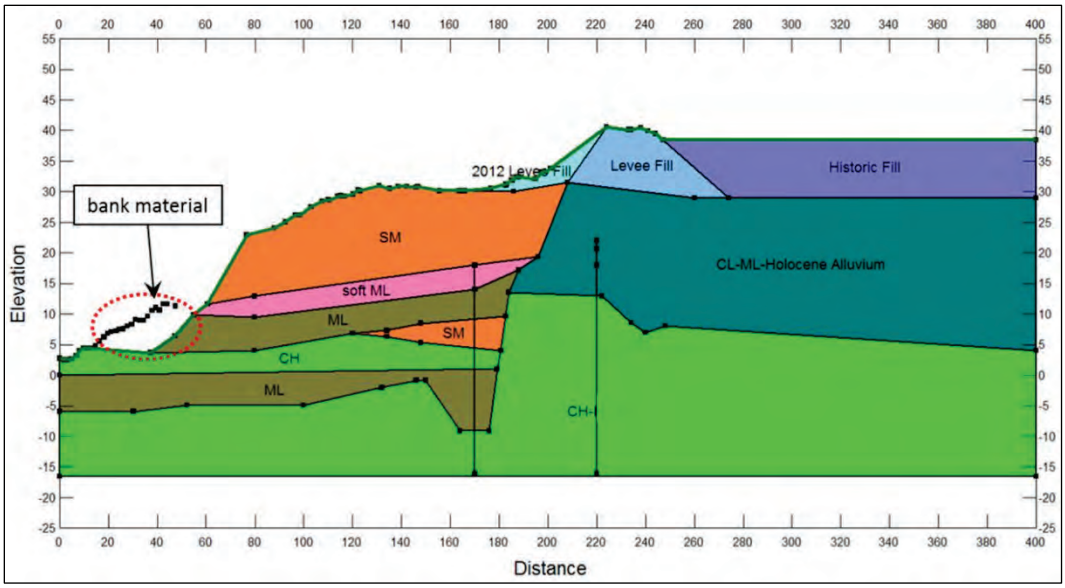
Figure 8.2. Post-levee instability model.

Figure 8.2 shows the model geometry used to evaluate the existing conditions. The difference between the surface shown in Figure 8.1 and that used in Figure 8.2 was any material that was considered to be sloughing material was left out of the analysis. This removal was done because in a high-water event; river velocities in this part of the channel would likely wash this material away.

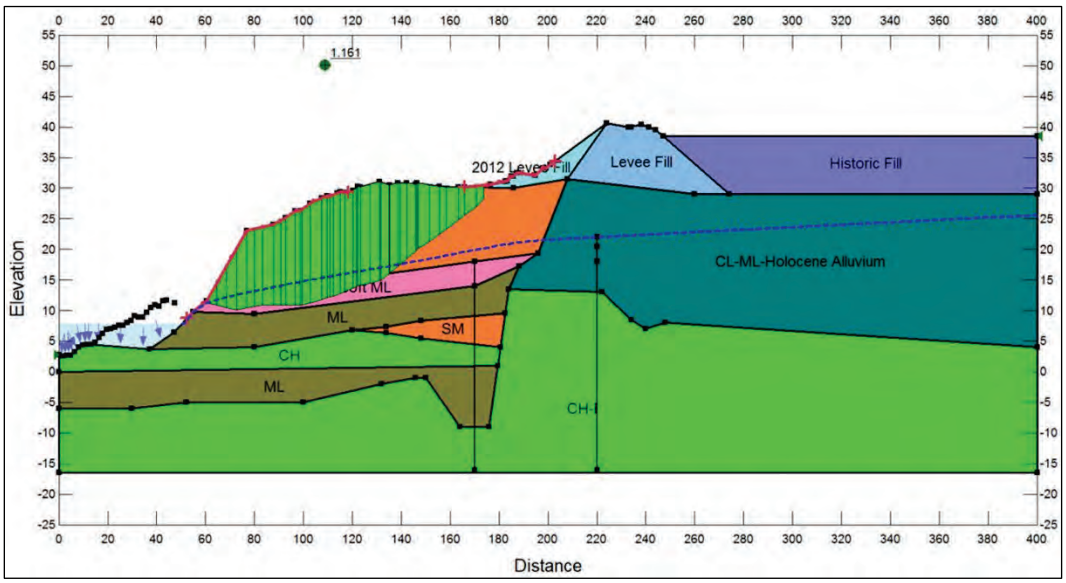
Figure 8.3. Results of the steady state loading condition, river elevation 7.77 ft.

Table 8.1 shows that the factors of safety for the steady-state analysis are relatively insensitive to the loading condition. The reason is that both analyses have the same type of failure surface, and there are a lot of slices that are well below the phreatic surface in both the high- and low-water evaluations. The failure surface is shown in Figure 8.3. An important finding of this study is that the water elevation of Lake Brown is contributing to the low factors of safety in both evaluations. It is also important to note that the shear strength of the “soft ML” material is modeled as undrained. If the soft material was allowed to drain or load slowly, the long-term shear strength would likely provide more resistance.

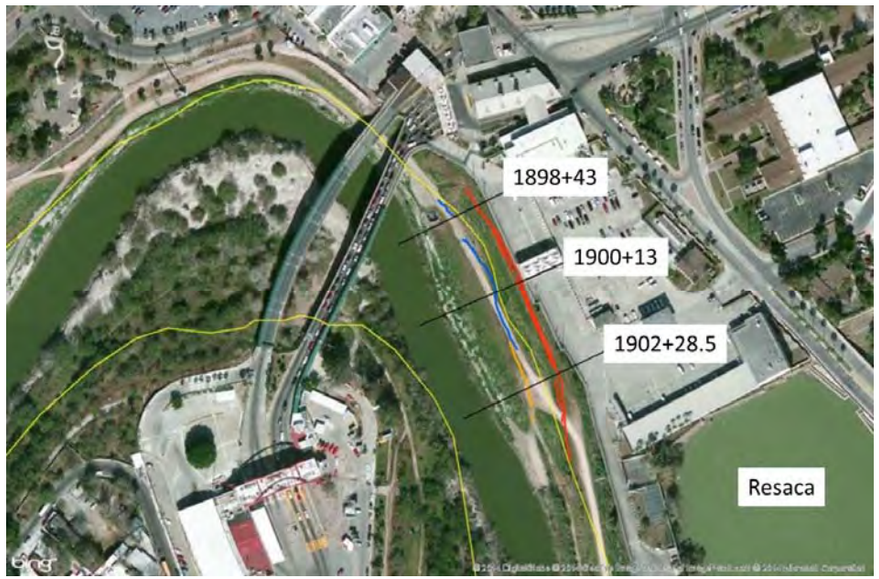
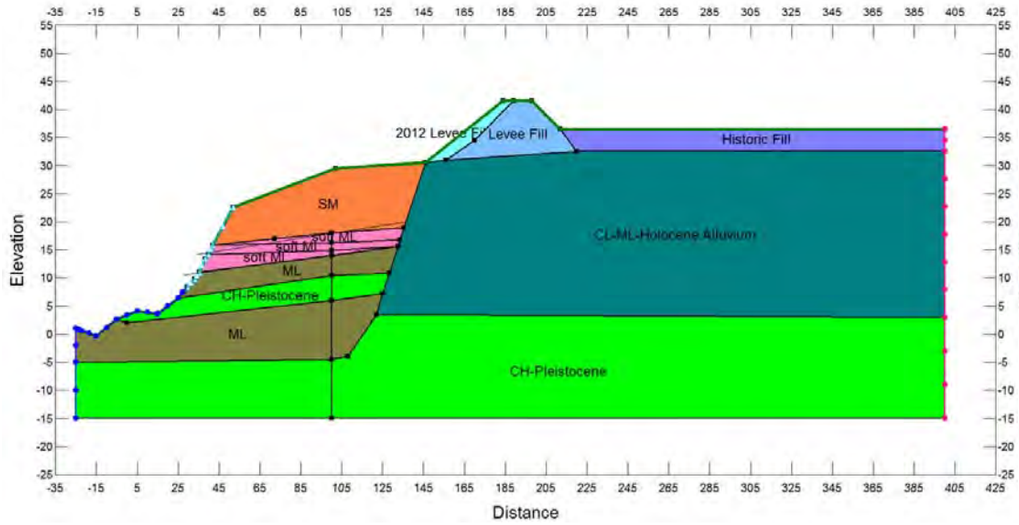
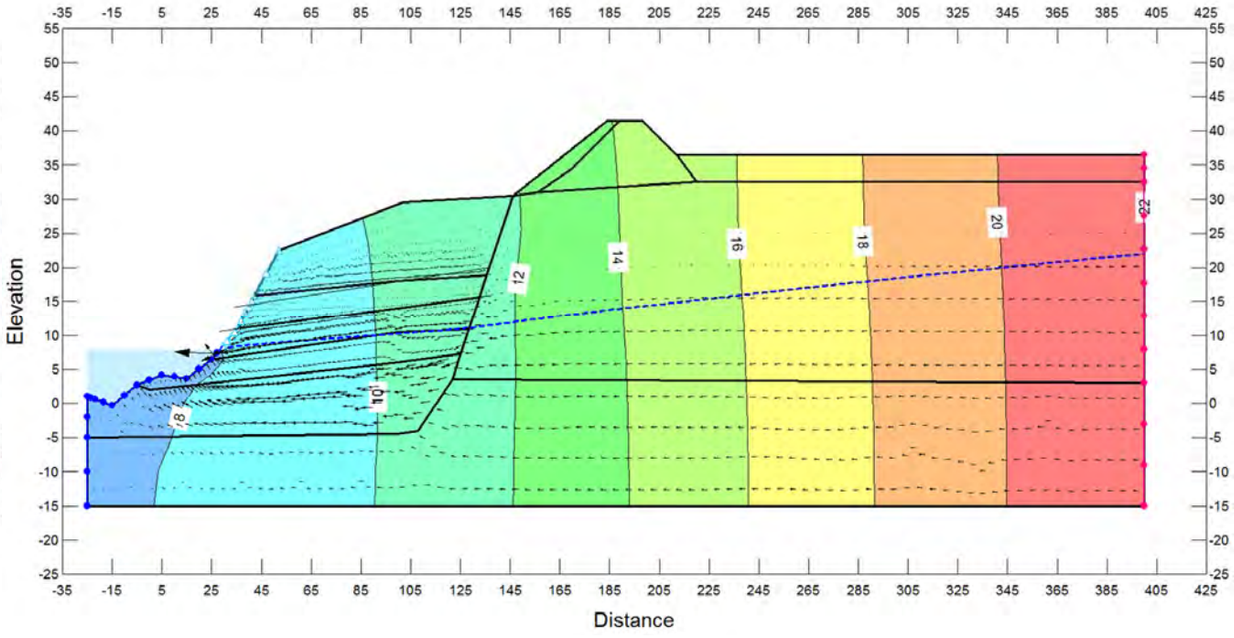
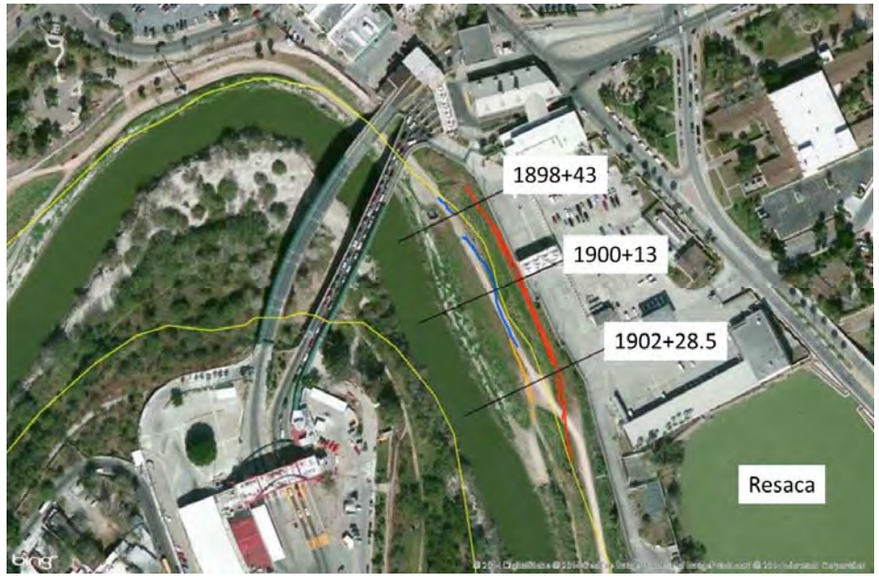
TRANSIENT FOS (HYDROGRAPH)

Minimum factor of safety (FoS): 1.02

material	unit weight (pcf)	c (psf)	phi (deg)
CH Pleistocene	121.98	200.00	24.00
CL-Holocene	123.37	800.00	17.30
SM	117.00	0.00	32.00
ML	119.38	300.00	32.60
2012 Levee Fill	127.34	620.00	29.20
Levee Fill	127.34	620.00	29.20
Historic Fill	127.34	200.00	24.00
soft ML	125.98	150*	0.00
*varied to explore impact of $S_{U,}$ actual range should fall between 150-500 psf

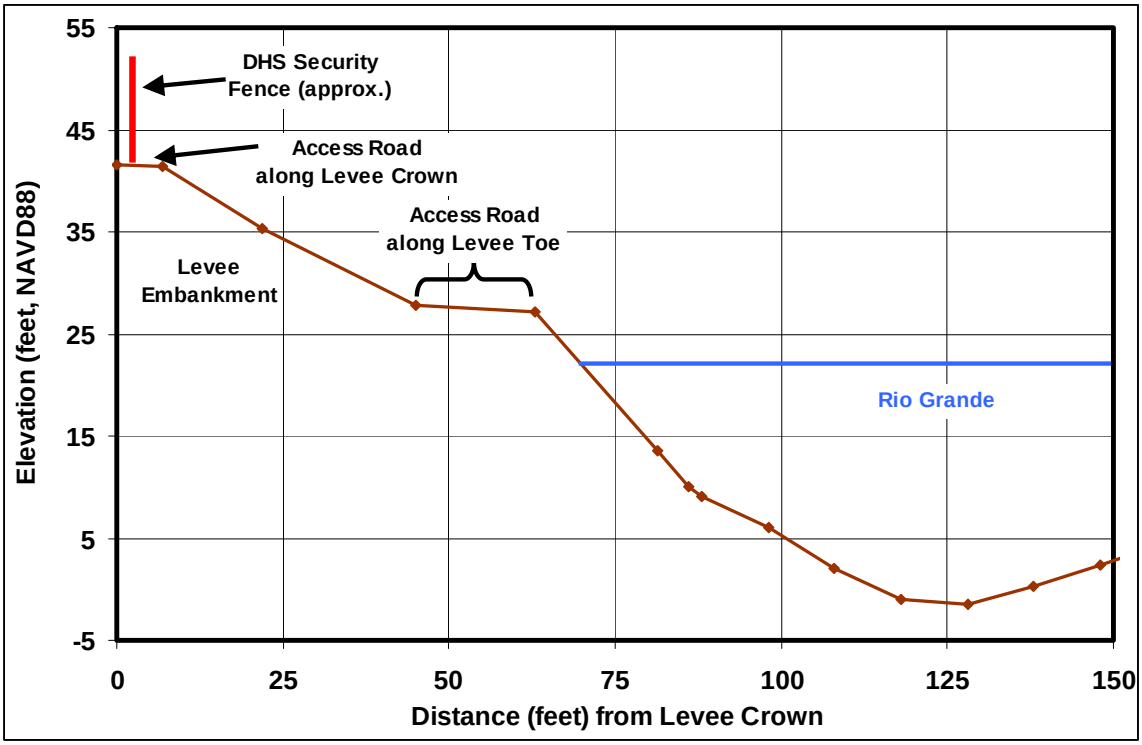
The IBWC is responsible for operation and maintenance of the U.S. levee along the left bank of the Rio Grande. Since the Rio Grande serves as the U.S. – Mexico border, the U.S. Department of Homeland Security (DHS) constructed a border security fence that is located in the access road along the crown of the levee (Figure 2). The fence obstructs access to the top of levee embankment, so access by the IBWC for flood fighting may be limited. The location of the levee embankment along the outside of the bend makes the embankment particularly subject to scour and erosion. To reduce the need for access to the levee during flood events, the IBWC is considering construction of an erosion protection along the

riverward slope of the levee embankment. This technical memorandum summarizes existing hydraulic conditions and the risk of the embankment to erosion. Additionally, the results of analyses of revetment alternatives are presented.

Figure 2. U.S. Levee Embankment, Access Roads, and DHS Security Fence

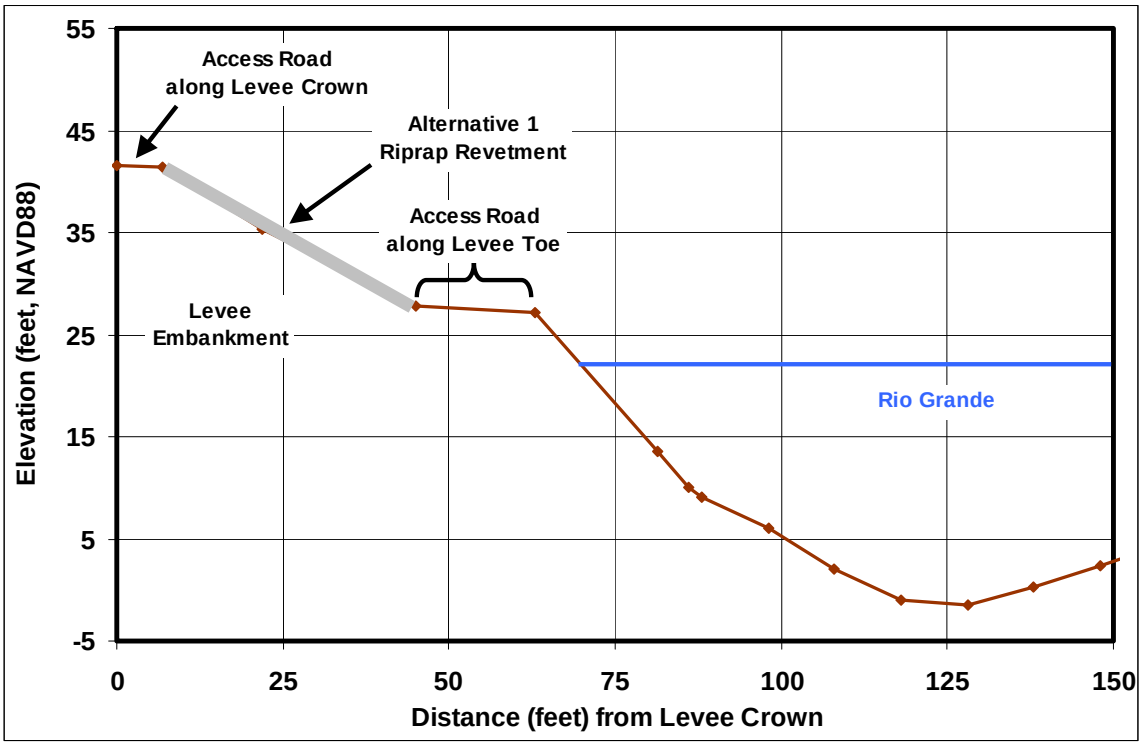
This alternative would provide embankment protection along the upper bank and reduce the potential for vegetation growth along the bank. This addresses the short-term condition but does not address the long-term condition in which the existing bank below the lower access road could begin to scour. Toe scour is probably the most frequent cause of failure of riprap revetments (USACE 1994). As the lower bank is eroded, the progressive erosion of the embankment will undermine the lower access road along the levee toe and the upper bank riprap revetment. This upper bank revetment would then fail and not provide any protection to the embankment.

Figure 3. Alternative 1 Embankment Protection – Riprap Revetment on Upper Bank Only

One alternative means of embankment protection is the construction of a riprap revetment along the upper bank (i.e., between the access road along the toe and the access road along the crown). This is illustrated in Figure 3.

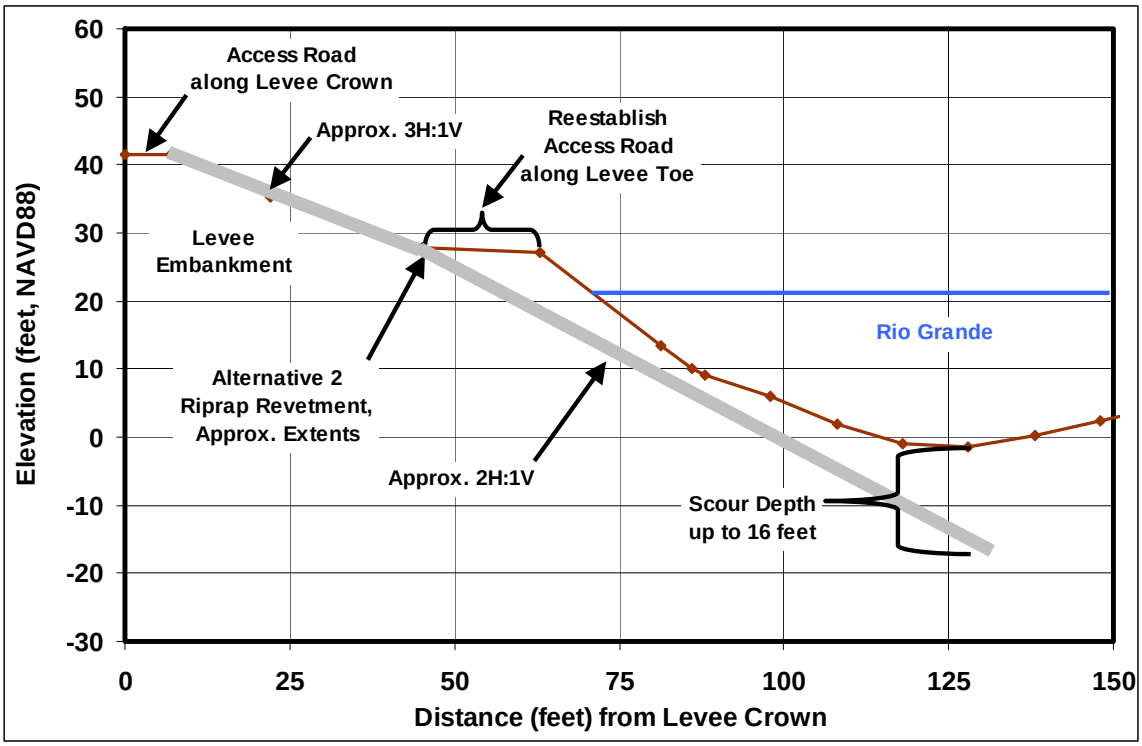
Figure 4. Embankment Protection – Riprap Revetment of Entire Bank (16 feet)

A second alternative is to construct a riprap revetment along the entire height of the bank from the upper access road down to a depth that will not be impacted by potential maximum scour. This alternative is illustrated in Figure 4. The advantage of this method is that it will fully cover the maximum potential scour depth with a uniform thickness of riprap revetment. The disadvantage of this alternative is that construction would require dewatering and substantial excavation, which will increase the cost of construction and potentially require environmental mitigation.

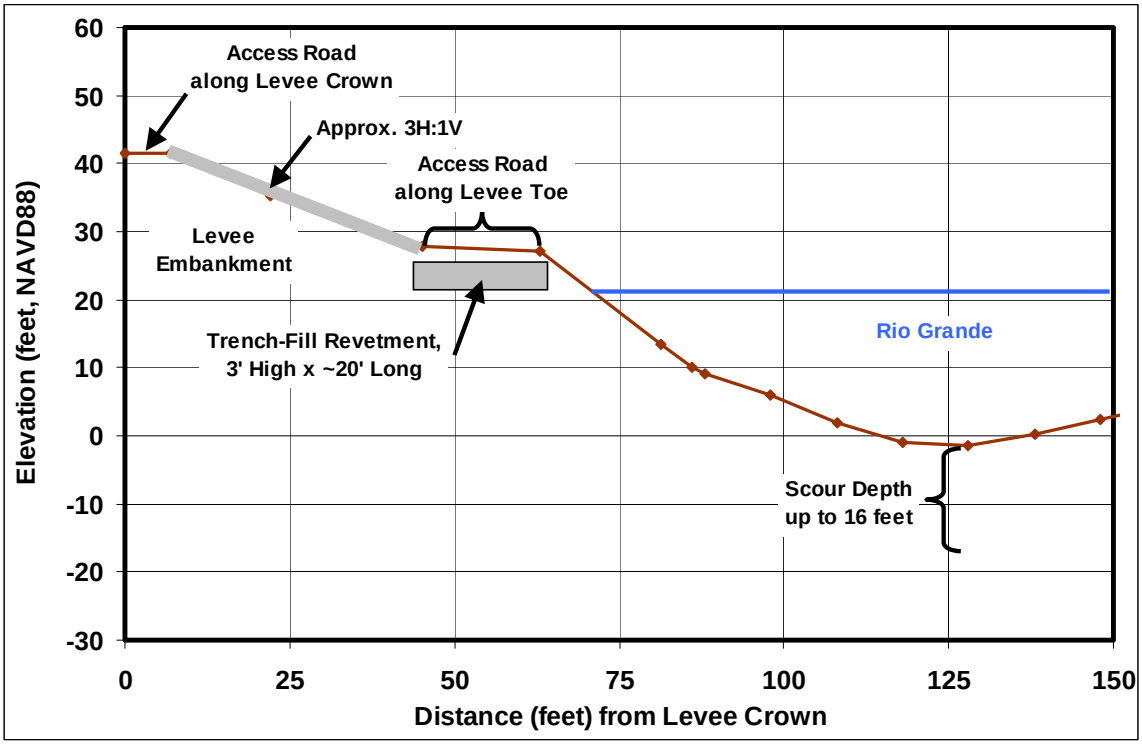
Figure 5. Embankment Protection – Trench-Fill Placement of Launching Stone

The available space to construct the trench is limited due to the depth of the channel; therefore, this alternative can provide only sufficient revetment for the toe (i.e. the expected bend scour depth of 16 feet). Applying Equation 4 with a F_S of 1.5, a T of 1 foot, and L_L of 36 feet (16 feet * √5), the required volume of stone is 54 cubic feet per foot of revetment. Using the recommended 2.5 to 3.0 times the desired thickness of stone layer, the height of the trench-fill should be approximately 2.5 to 3.0 feet. To achieve this required volume of stone, the distance the trench-fill needs to penetrate into the bank is approximately 18 to 22 feet (Figure 5).

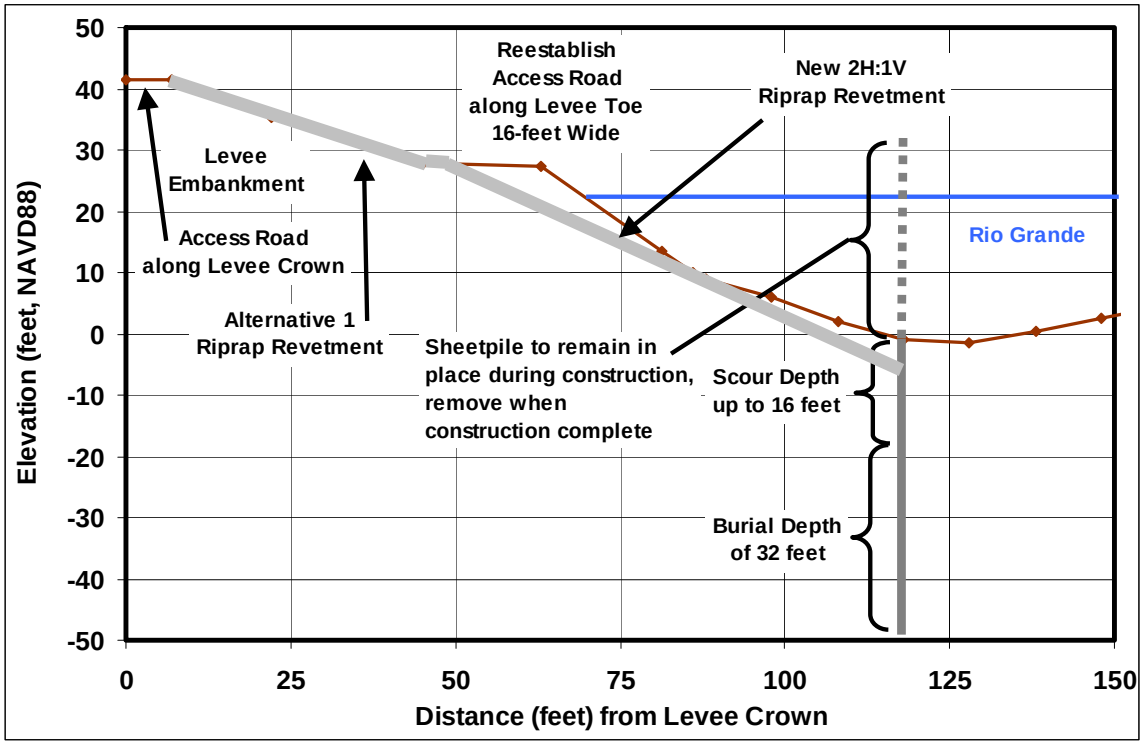
Figure 6. Embankment Protection – Riprap Upper Bank with Sheetpile for Future Scour

The fourth alternative uses sheetpile rather than rock to provide protection for future scour. Riprap revetment is provided along the existing channel slope, under the lower access road, and along the upper bank. As shown in Figure 6, the sheetpile would be left at an additional height during construction to facilitate the placement of rock along the existing channel bank (the additional height will be cut to ground elevation at the end of construction). The depth of sheetpile required to protect against bend scour is 16 feet so approximately an additional 32 feet of embedment is required below the scour depth for stability

(Figure 6). Future design phases would need to determine if sheetpile or king piles are required for stability.

To protect the bank between the top of the sheetpile and the existing lower access road along the levee toe, a new riprap revetment would be constructed. This revetment cannot reduce existing conveyance and can be no steeper than 2H:1V so a new 16-foot wide access road would need to be overbuilt on the levee toe and protected in place.
